THE HELIOS EXPERIMENT 5 ANTENNA MECHANISM

by E. J. W. Müller, Dipl.-Ing.

DFVLR-BPT, Germany

This paper describes the Experiment 5 Antenna Deployment problem on board HELIOS A, the failure analysis, and changes in design, test, and operation which led to a successful deployment of both antennas during the early HELIOS B mission phase.

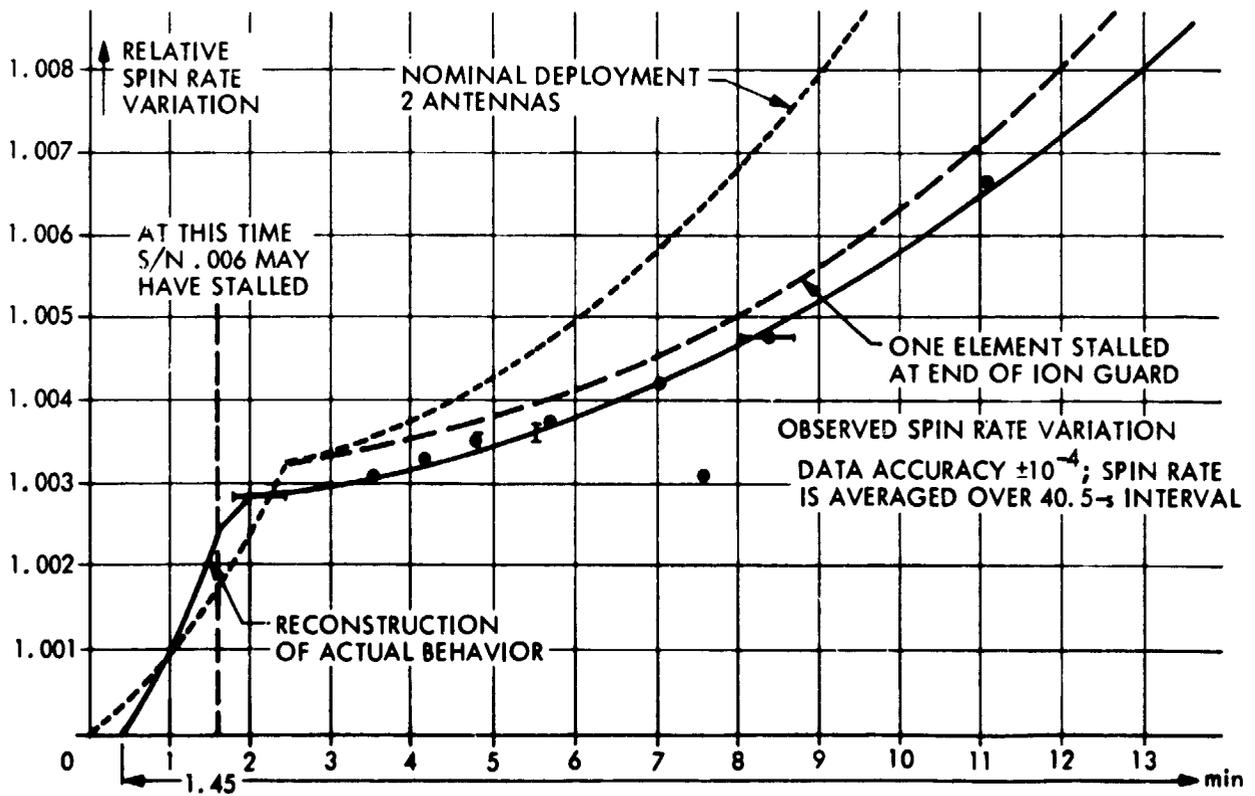
- Only one of the motors was switched off automatically by the end switch
- The spacecraft spin rate change due to the change in the spacecraft spin moments of inertia was from 52.966 rpm to 51.072 rpm instead of 49.36 rpm
- One antenna element was grounded to the spacecraft structure

From this information, it can be deduced that both units drew approximately the predicted current (0.4 A each) and that one unit automatically switched off after a run time of 32.5 min. These data also show clearly that the second unit did not switch off automatically. Only when the power disable command for the antenna units was executed did the current reading drop to the value it had prior to antenna deployment. The solar aspect angle changed during the deployment by 0.2°, which also indicates a malfunction of one antenna element because both antennas are mounted about 10 cm

Fig. 2 Spin rate variation on board HELIOS A as function of time

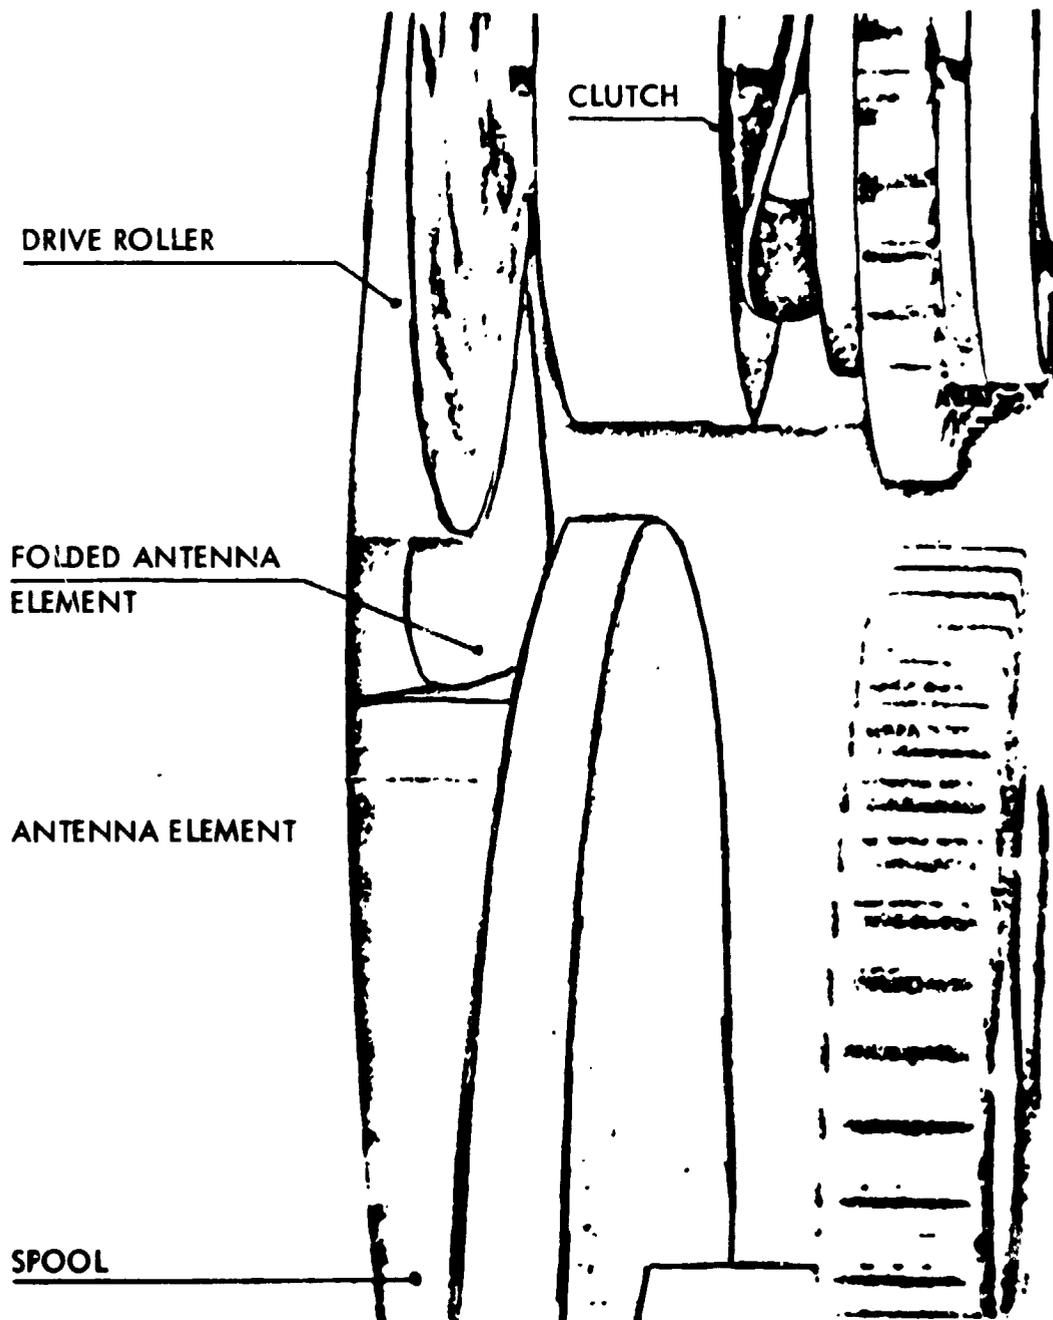
The most probable failure mode which could have caused the problem on HELIOS A was found in tests No. 1.2 and 1.3 when the effect of the ion guard on the antenna element was determined. When the ion guard and the antenna system are assembled for S/C integration, the ion guard is compressed to about 30 cm for storage. During storage, it is additionally twisted axially through two to four turns due to the normal rotation of the helical spring inside the ion guard. When the ion guard deploys (simultaneously with the antenna element), it imparts a torque to the antenna element transmitted by the friction between ion guard end flange and antenna tip mass. When the direction of the ion guard torque is such that the antenna cross section tends to open, the antenna element is caused to bind at the end of the ploy. As a result, a blooming or buckle occurs between the drive roller and the ploy. When this effect was detected at Fairchild, approximately 5 seconds had elapsed between stall of element and power switch-off. The 5-second delay was enough to damage the antenna element. A possible explanation was that one antenna worked properly and that it was impossible to overcome the failure on board HELIOS A by retracting and deploying maneuvers of the S/N 006 unit. Figure 3 shows a close-up view of the failed mechanism after test step 1.2.

Fig. 3 Close-up view of the failed mechanism after test step 1.2

Based on S/C noise data obtained by Experiment 5a on board HELIOS A, the experimenter requested the elimination of the foldable ion guard. It should be replaced by a rigid electrically conducting tube of 10-cm diameter and 0.8-m length to provide electrostatic shielding of the antenna base from noise originated by the spacecraft solar array. This modification completely eliminated the interaction between ion guard and antenna element. Together with the elimination of the foldable ion guard, the detent spring inside the mechanism could be removed. This spring was necessary to hold the antenna element in its stored position during vibration loads, because of the pulling force of the ion guard on the antenna element.

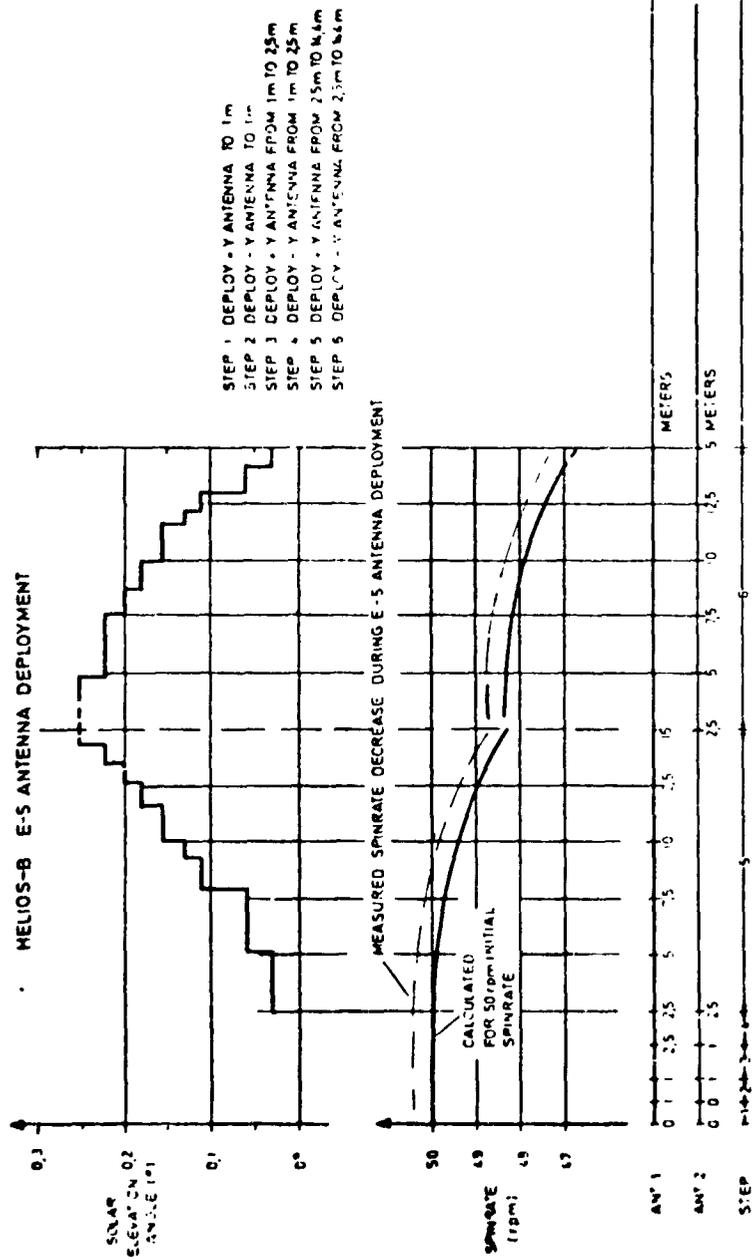
Steps 1 to 6 of the deployment were performed successfully on the first day of the HELIOS B mission. All above-mentioned parameters were monitored and plotted and did not deviate from the predicted values. Figure 4 shows the plot of the spacecraft spin rate and solar deviation angle as function of deployed antenna length. Steps 7 and 8 were performed successfully during the third Goldstone pass on the third day of the mission.

Fig. 4 HELIOS B Experiment 5 antenna deployment steps 1 to 6
